**TEARDOWN REPORT  
OF TWO MODEL TPE331-10T-515K TURBOPROP ENGINES  
SERIAL NUMBER P-79297C AND P-79001C**

**October 8, 2014**

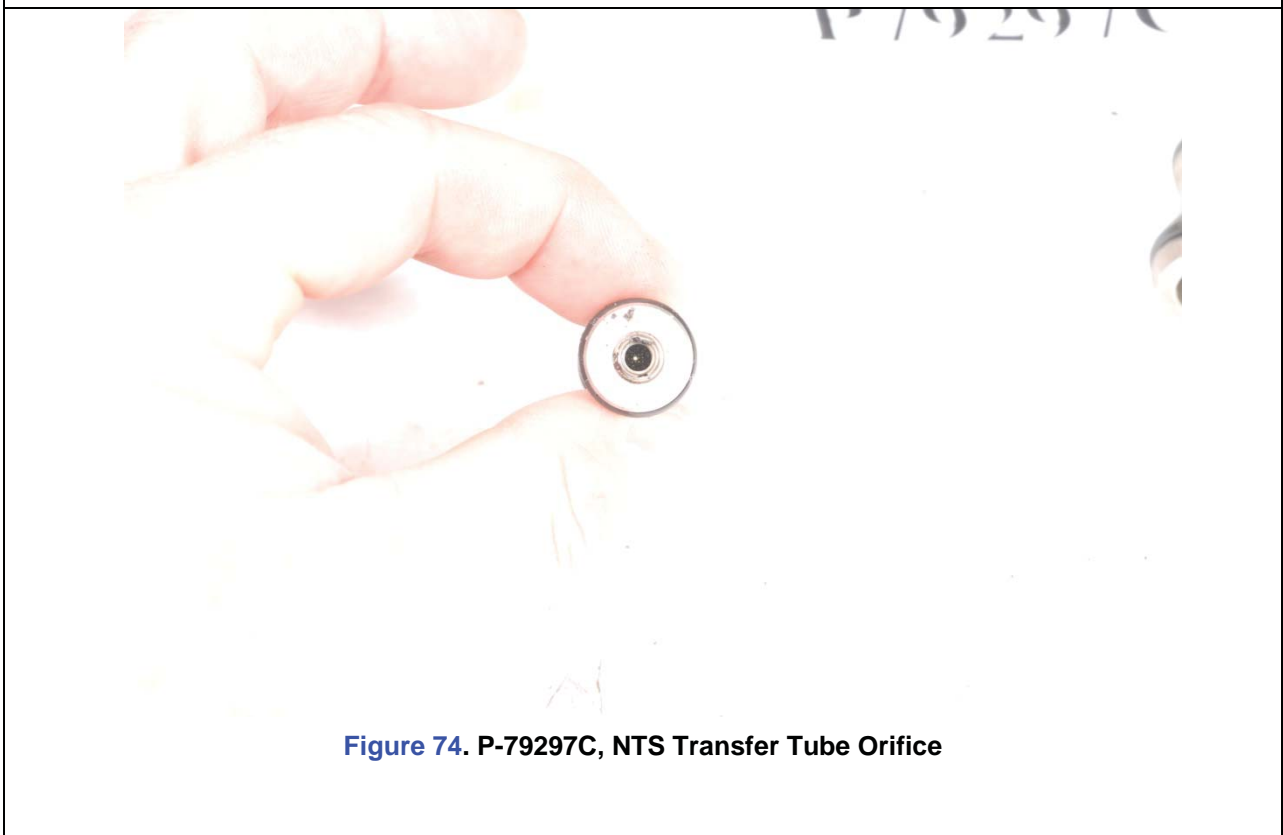
**Figure 73.** P-79297C, NTS Transfer Tube/Restrictor Assembly and Feather Valve Oil Transfer Tube

- (p) NTS Transfer Tube and Orifice Assembly: (Figure 73)
  - The NTS transfer tube was intact.
  - The NTS transfer tube orifice was unobstructed. (Figure 74)

- (q) Feather Valve Oil Transfer Tube: (Figure 73)
  - The feather valve oil transfer tube was intact.
  - The feather valve oil transfer tube was unobstructed.

- Both of the feather valve oil transfer tube o-rings were undamaged.
- (r) Torque Sensor Oil Screens: (Figure 75)
  - The torque sensor oil screens were intact and appeared to be undamaged.

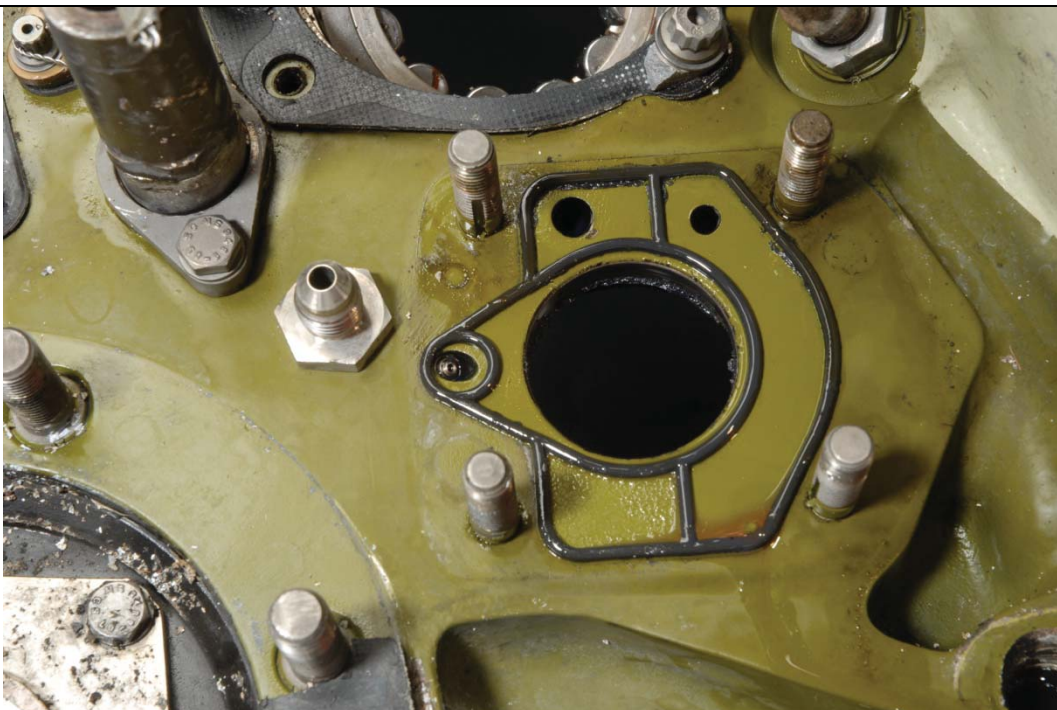
**Figure 75. P-79297C, Torque Sensor Oil Screen**

- The torque sensor oil screens did not contain debris upon disassembly.
- (s) Propeller Governor “Spider” Gasket: (Figure 76)
  - The propeller governor “spider” gasket was intact.

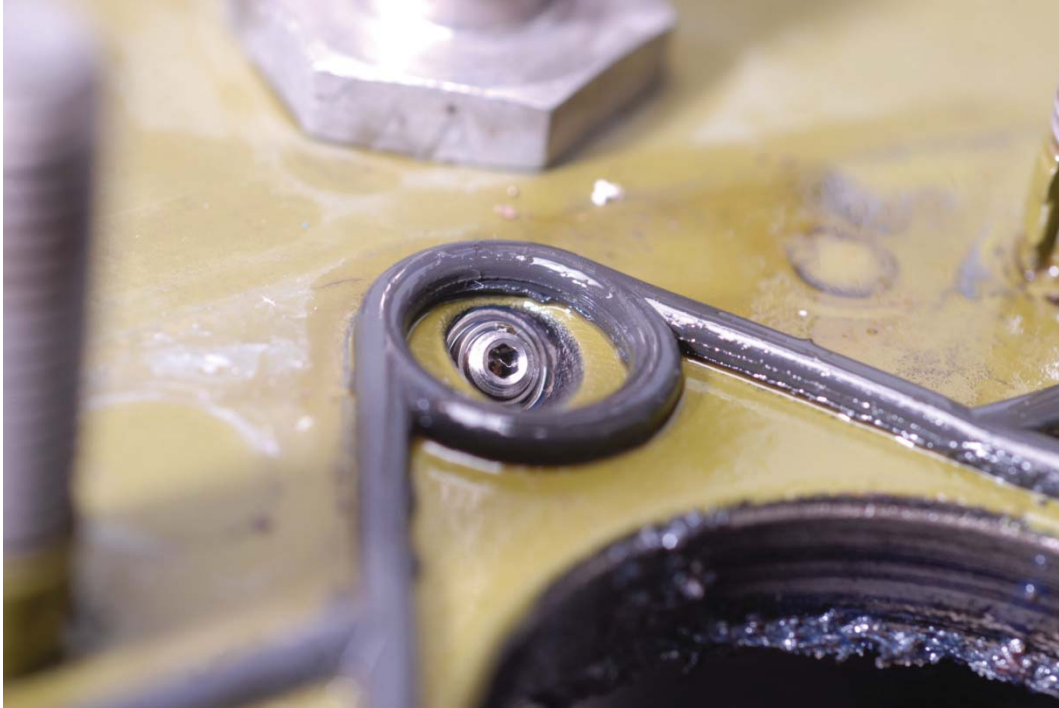
**Figure 76. P-79297C, Propeller Governor "Spider" Gasket**

- Gasket flashing was observed around several locations around the gasket.
- (t) “Lee” Check Valve:
  - The “Lee” check valve was not accessed.
- (u) Propeller Governor Reset Orifice: (Figure 77)

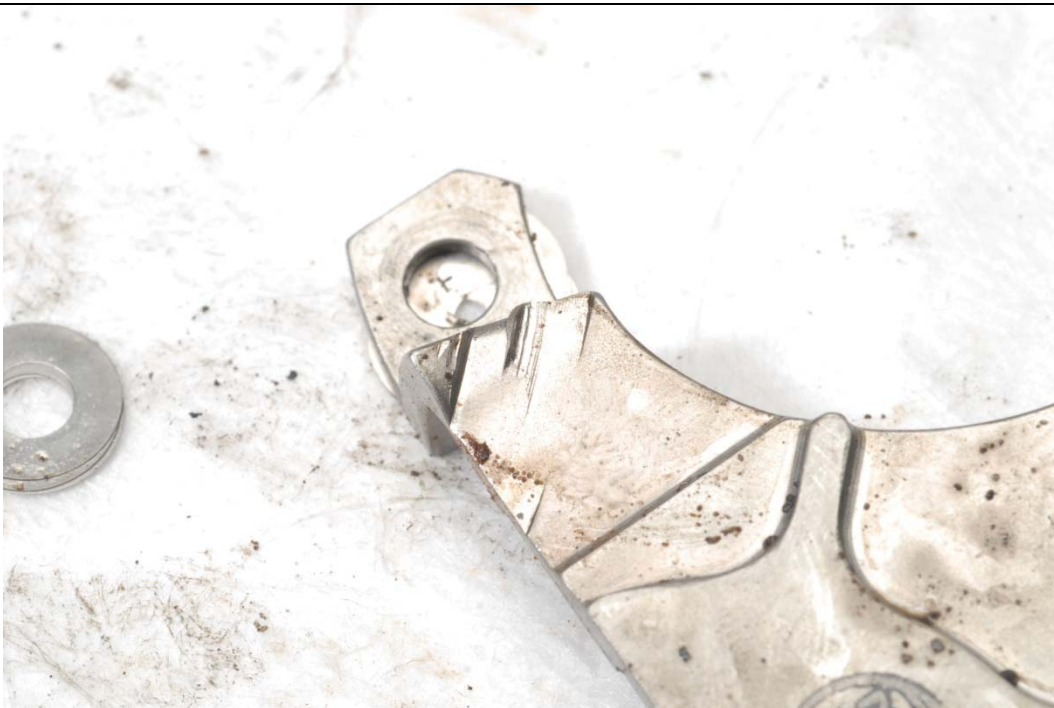
**Figure 79.** P-79297C, Rotational Scoring on the Forward Housing Surface

- Serial Number: P-7083C
  - The torque sensor housing displayed rotational scoring on the forward housing surface (Figure 79) with corresponding rotational damage to the sun gear nut.

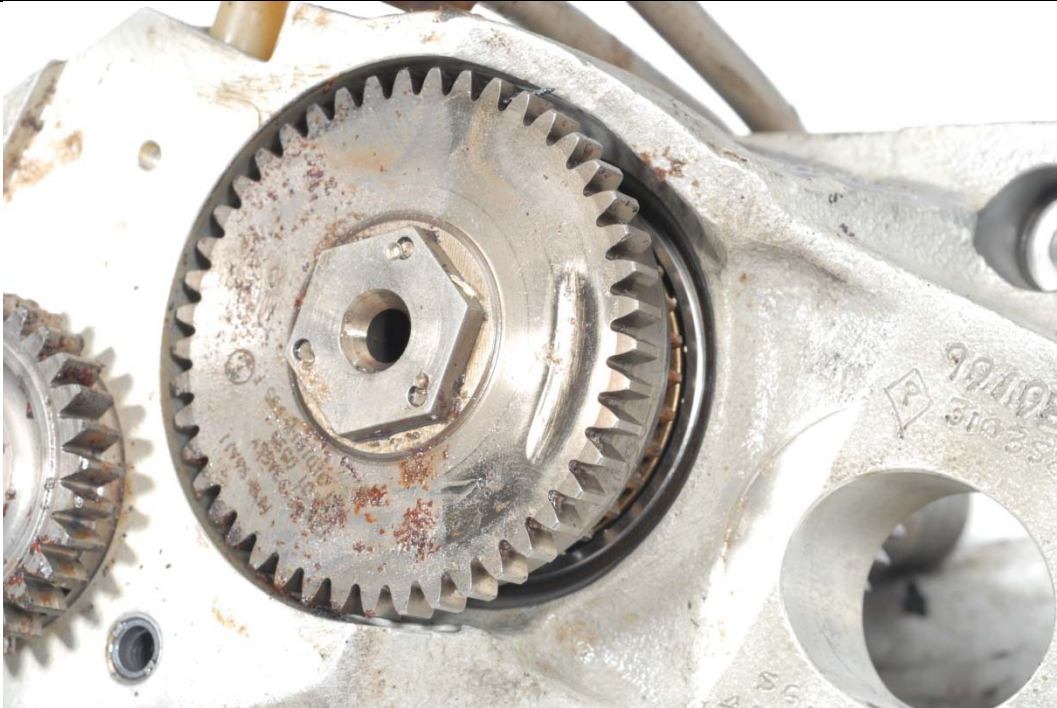
**Figure 80.** P-79297C, Static Impact Marks on the Forward Surface of the Torque Sensor

- There were static impact marks on the forward surface of the torque sensor (Figure 80) indicating contact with the bull/sun gear aft bearing liner.

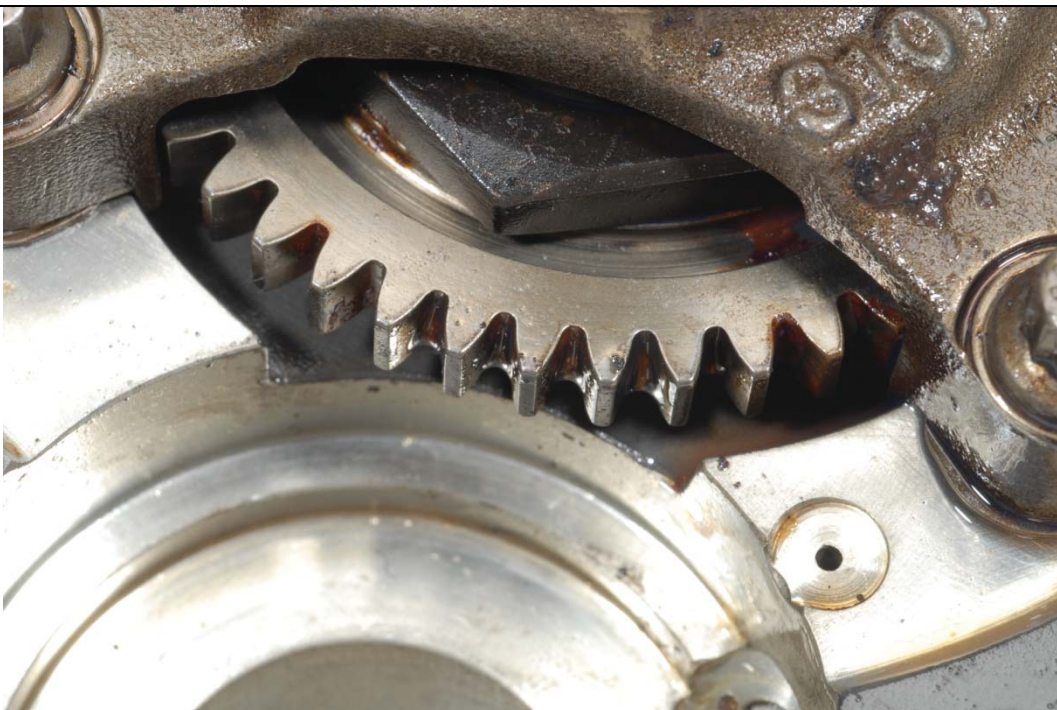
**Figure 81.** P-79297C, Helical Cam Gear

- (c) Helical Cam Gear: (Figure 81)
  - The helical cam gear was free to rotate.
  - The helical cam external gear teeth were intact.
  - The helical cam gear external teeth appeared to be undamaged, except for the noted corrosion.

- The helical cam gear could not be removed from the first DDFC idler assembly in the torque sensor.
- (d) First Direct Drive Fuel-Control (DDFC) Gear Assembly (through the torque sensor housing): (Figure 82)

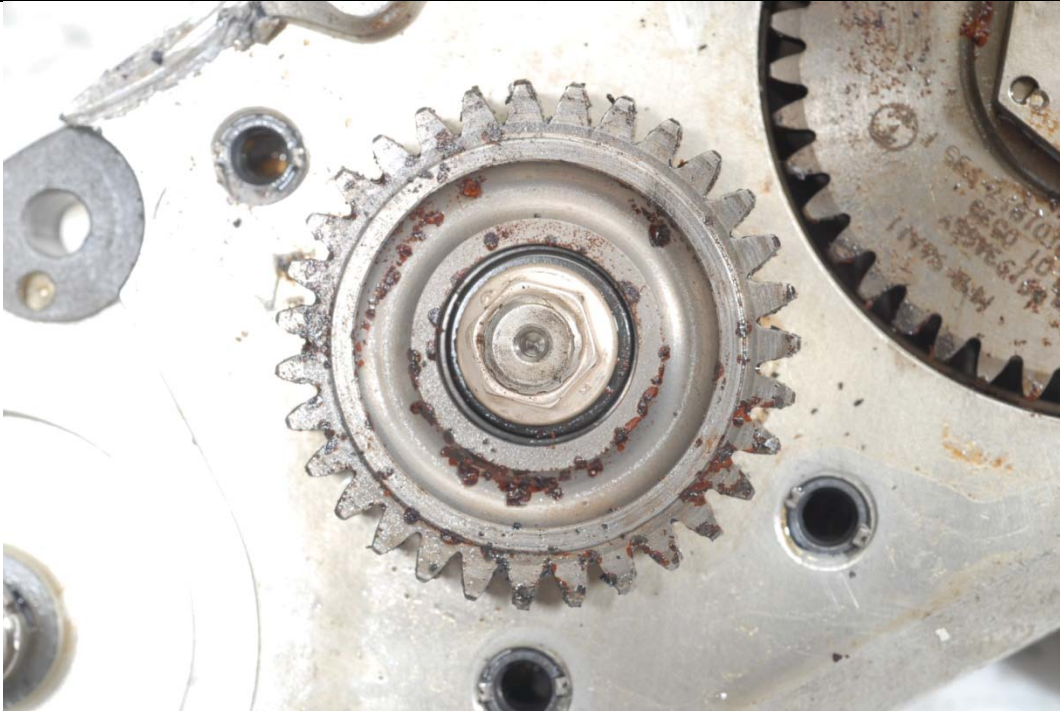
**Figure 82.** P-79297C, First Direct Drive Fuel-Control (DDFC) Gear

- The first DDFC gear was free to rotate.
  - The first DDFC gear appeared to be undamaged, except for the noted corrosion.
- (e) Second DDFC Gear Assembly (through the torque sensor housing): (Figure 83 and Figure 84)

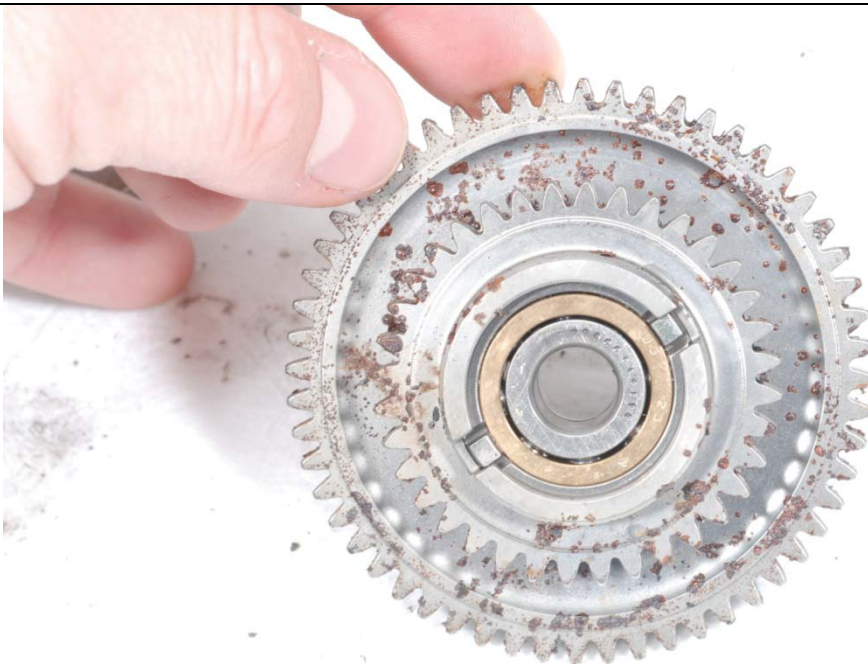
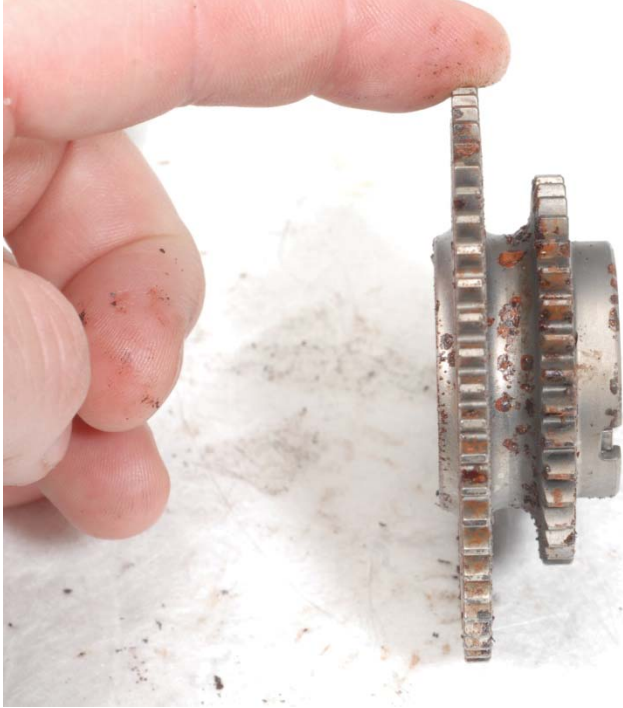
- (f) Third DDFC Gear: (Figure 85 and Figure 86)
  - The third DDFC gear was free to rotate.
  - Both gears of the third DDFC gear appeared to be undamaged, except for the noted corrosion.

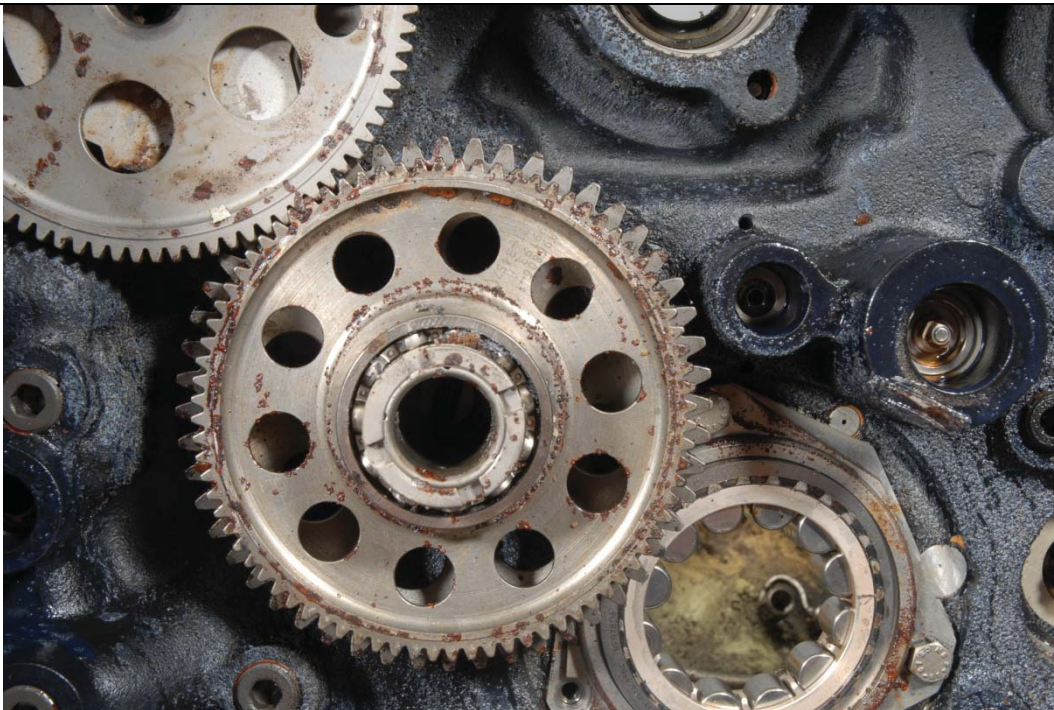
**Figure 87.** P-79297C, Third DDFC Gear

- Both gears of the third DDFC gear were intact. (Figure 87)
  - Both bearing(s) of the third DDFC gear appeared to be undamaged, except for the noted corrosion, but were not removed for detailed inspection.

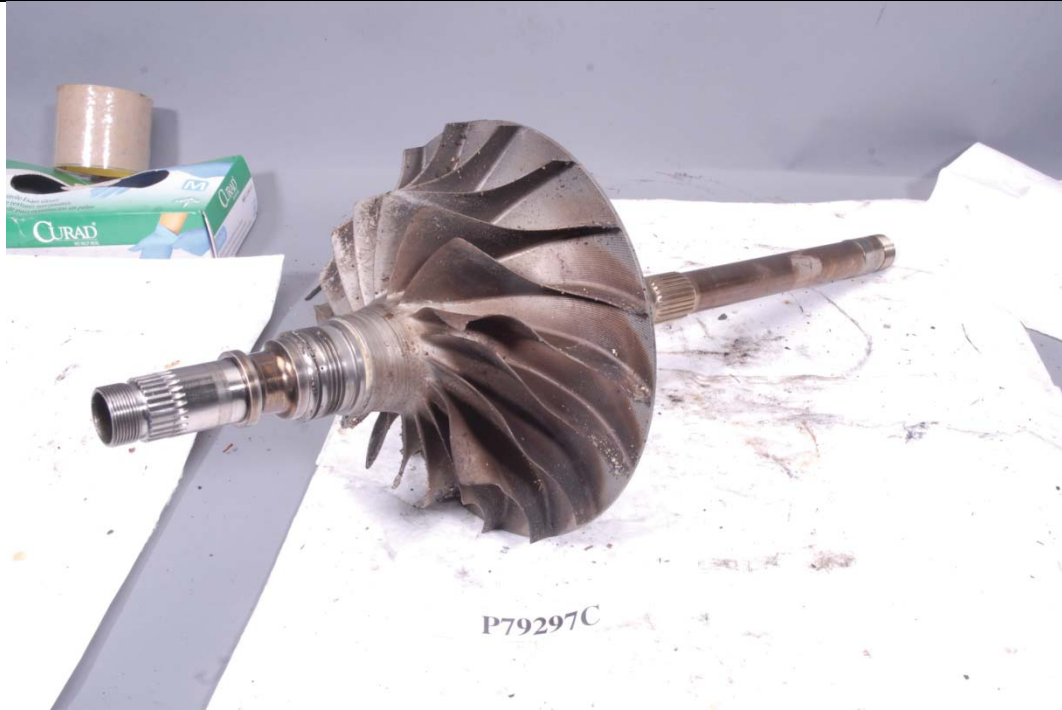
**Figure 88.** P-79297C, Fourth DDFC, Tach/Generator Drive Gear and Shaft Assembly

- (g) Fourth DDFC, Tach/Generator Drive Gear, and Shaft Assembly: (Figure 88)
  - The fourth DDFC gear was intact.
  - The fourth DDFC gear appeared to be undamaged, except for the noted corrosion, but was not disassembled for detailed inspection.

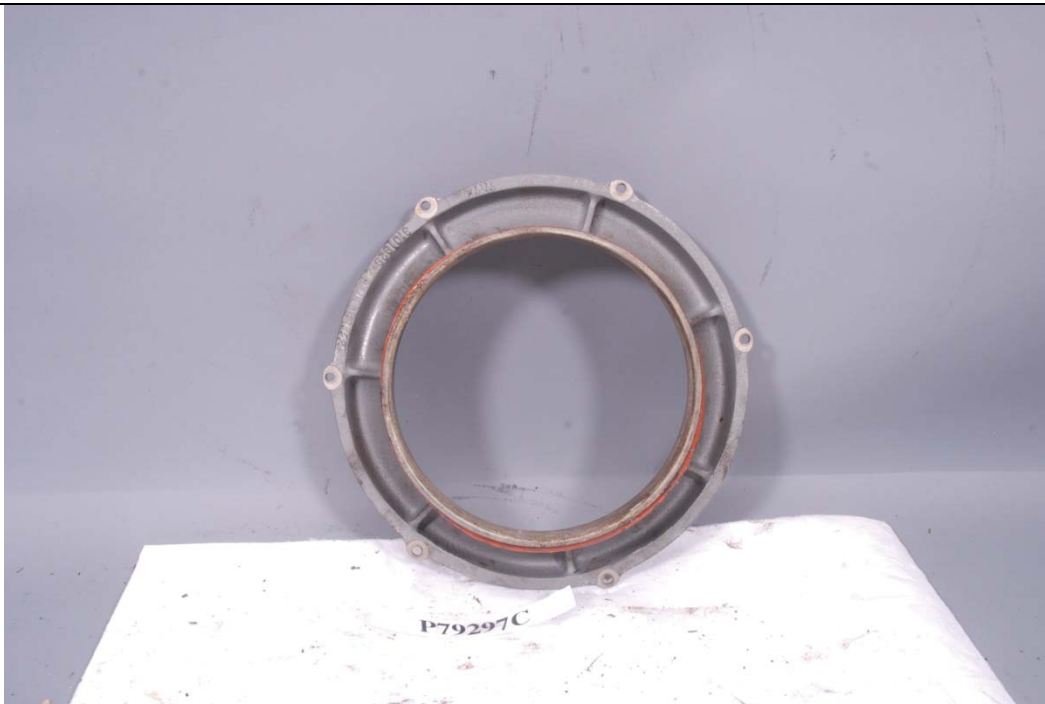
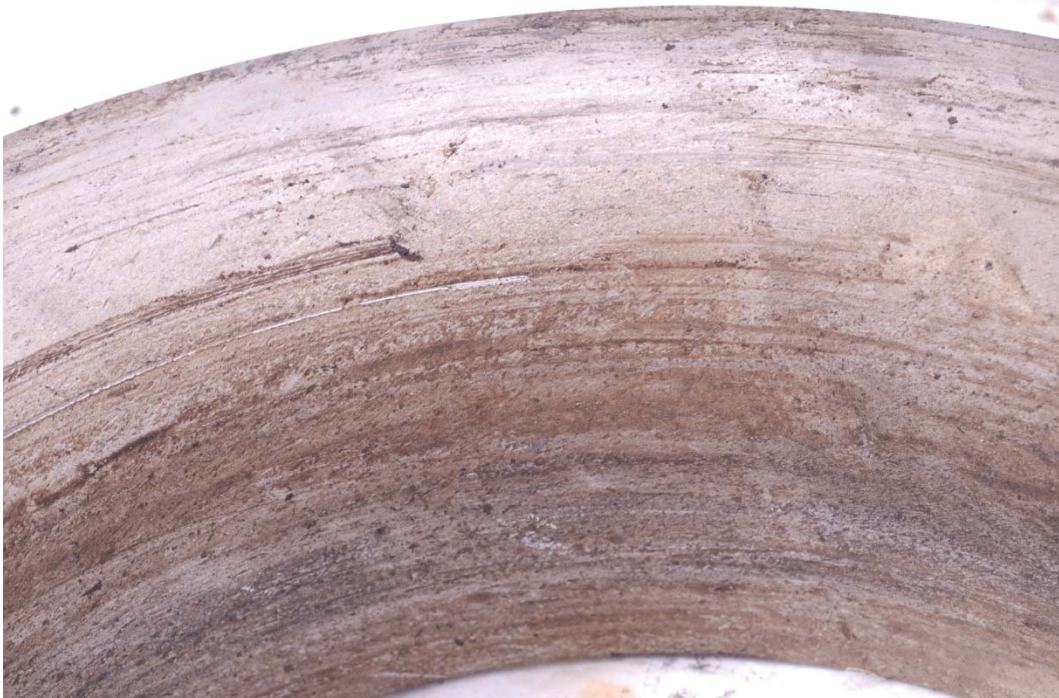
**Figure 93.** P-79297C, First-Stage Compressor Impeller Shroud, ALF

- (c) First-Stage Compressor Impeller Shroud: (Figure 93 and Figure 94)
- The first-stage compressor impeller shroud displayed a shroud rub through approximately 360 degrees at the exducer and inducer area(s) (Figure 95) with corresponding rotational scoring on the impeller shroud line edge.

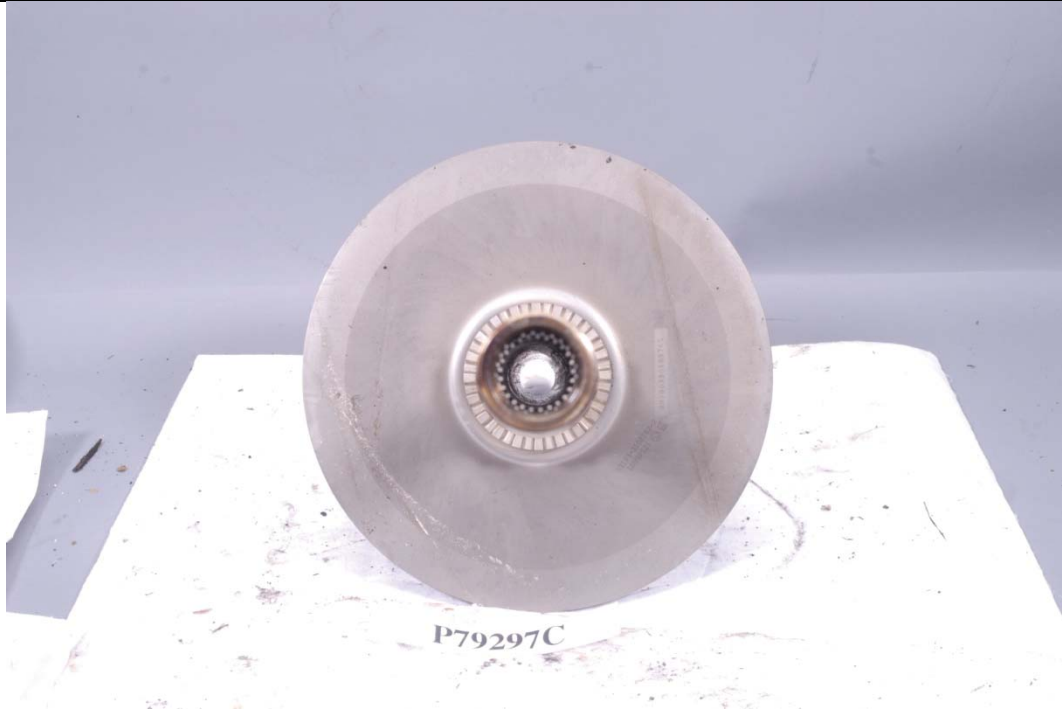
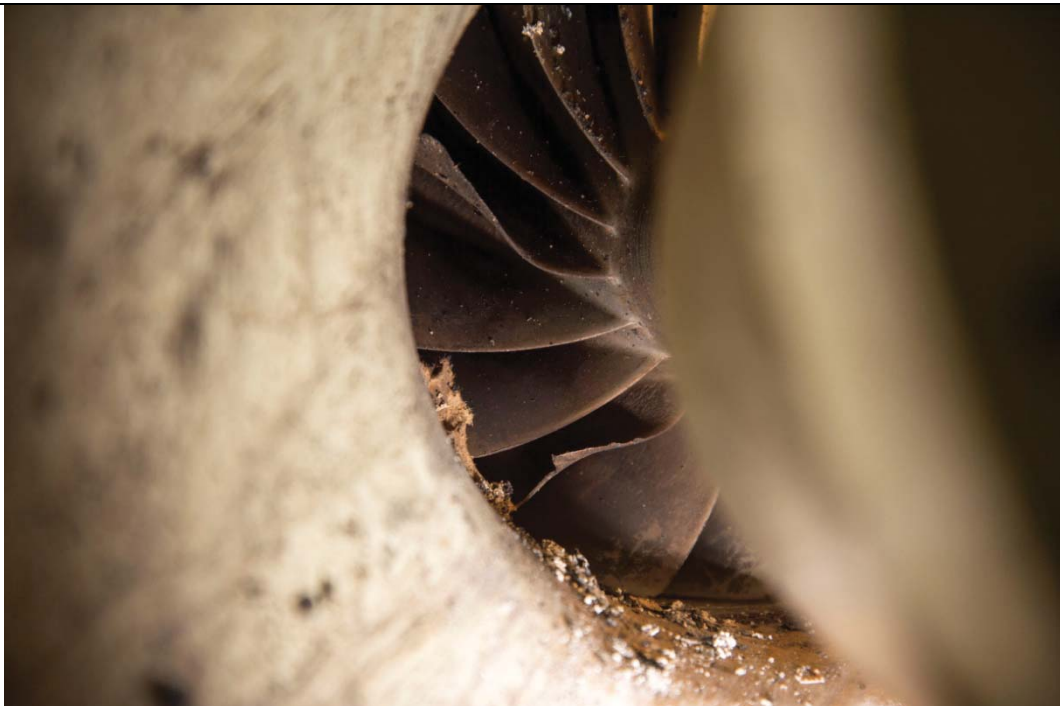
**Figure 96.** P-79297C, First-Stage Compressor Impeller, FLA

- (d) First-Stage Compressor Impeller: (Figure 96 and Figure 97)
- Part Number: 3108182-2
  - Serial Number: 97035-0105765
  - Lot Number: 99-P121
  - As viewed through the gearcase air inlet, the first-stage compressor impeller had several non-adjacent blades bent in the opposite direction of rotation at the leading edge outer diameter (Figure 98).

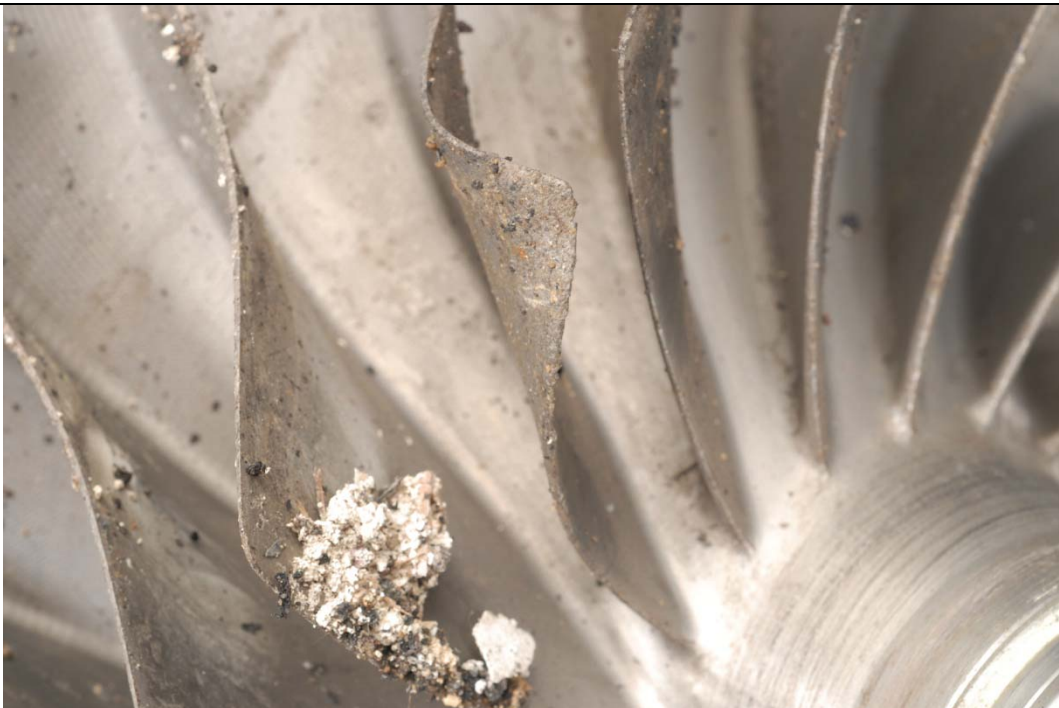
**Figure 99.** P-79297C, First-Stage Compressor Impeller Shroud Line Scoring

- There was earthen debris adhering to the first-stage compressor impeller blades and flow path surfaces.
  - The first-stage compressor impeller blades displayed rotational scoring on the shroud line edge (Figure 99) with corresponding rotational scoring on the first-stage compressor impeller shroud.

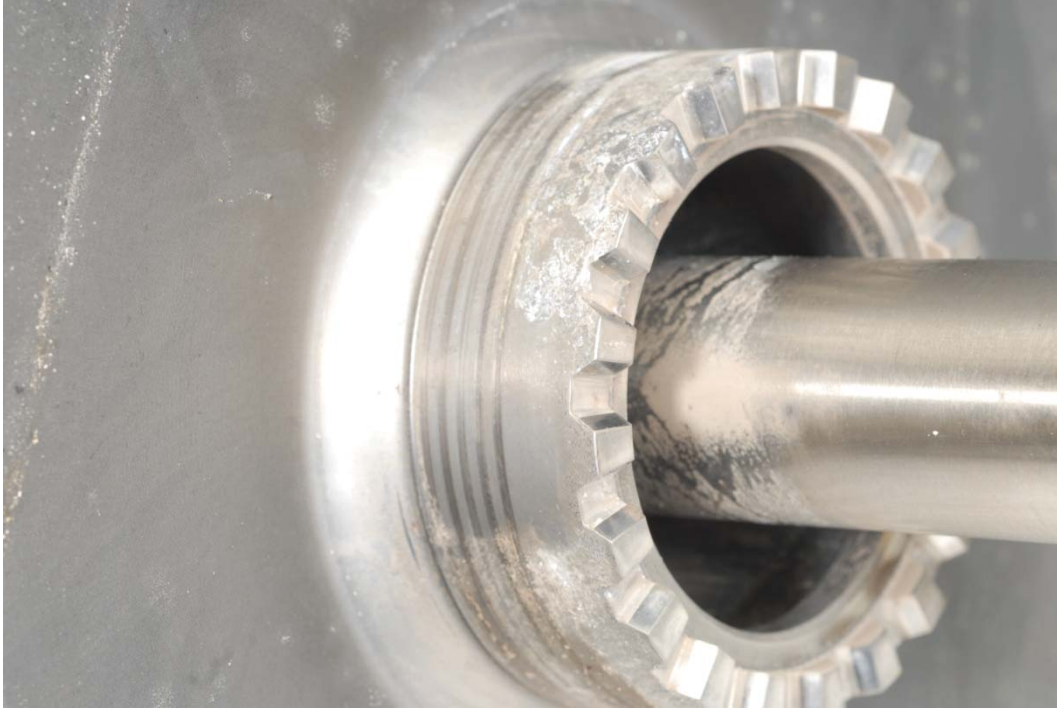
**Figure 100.** P-79297C, First-Stage Compressor Impeller Leading Edge Erosion and Bending

- The first-stage compressor impeller blades had the leading-edges bent opposite to the direction of rotation on 5 blades.
  - The first-stage compressor impeller blades had the leading edge of all blades damaged (rough / pitted) due to foreign object damage. (Figure 100)

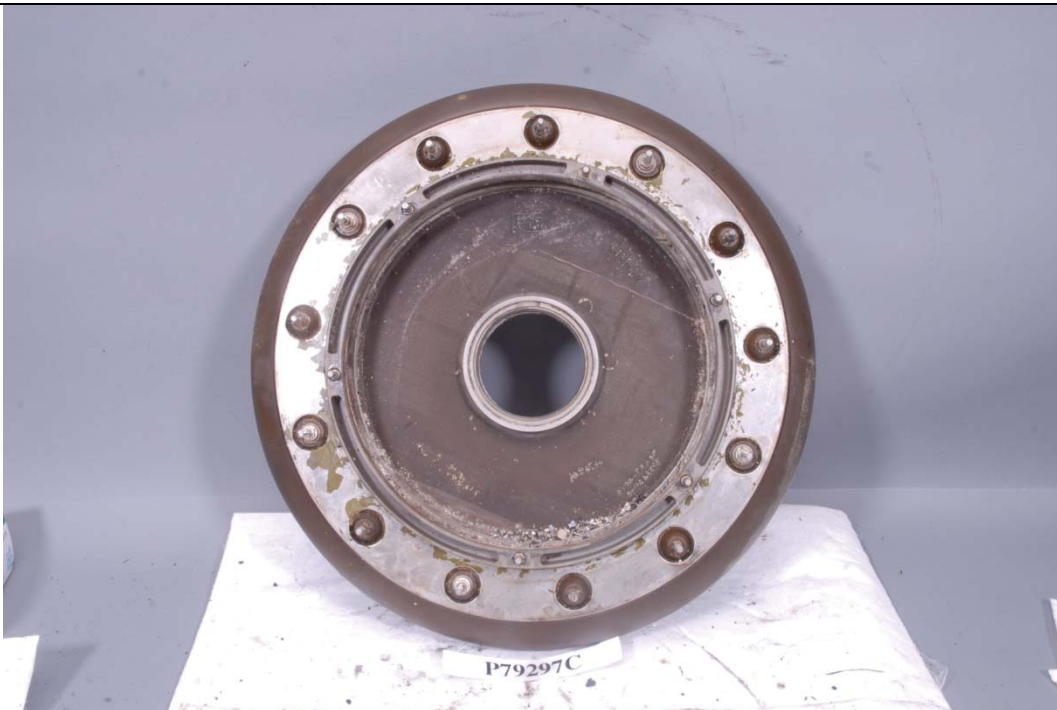
**Figure 101.** P-79297C, First-Stage Compressor Impeller Knife Seal Witness Marks

- The first-stage compressor impeller displayed rotational scoring through approximately 360 degrees on the aft hub (Figure 101) consistent with knife seal witness marks from the crossover duct.

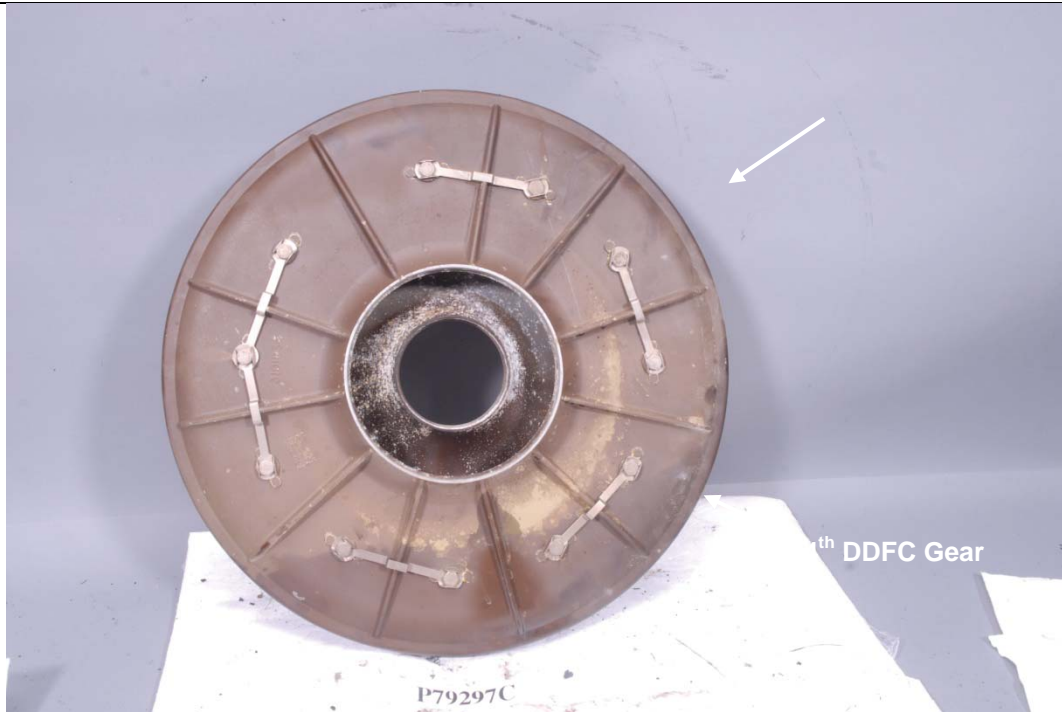
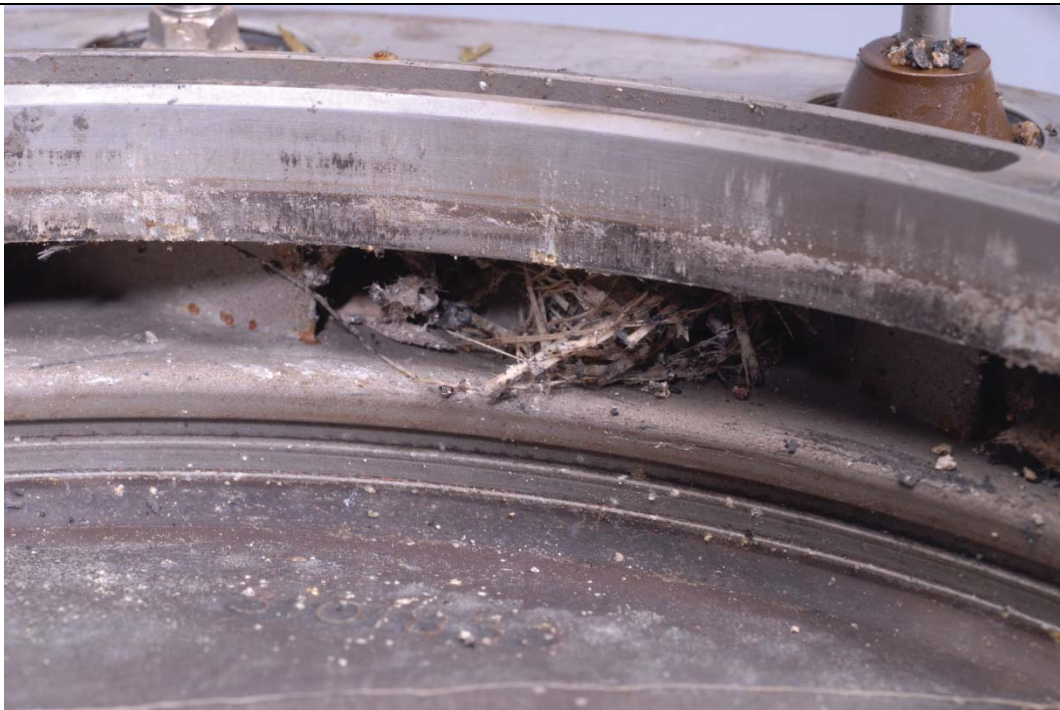
**Figure 102.** P-79297C, First-stage Compressor Diffuser, FLA

- (e) First-stage Compressor Diffuser (crossover duct): (Figure 102 and Figure 103)
- The first-stage compressor diffuser was intact.
  - The first-stage compressor diffuser displayed damage consistent with foreign object damage to the leading edges of most of the vanes. (Figure 104)

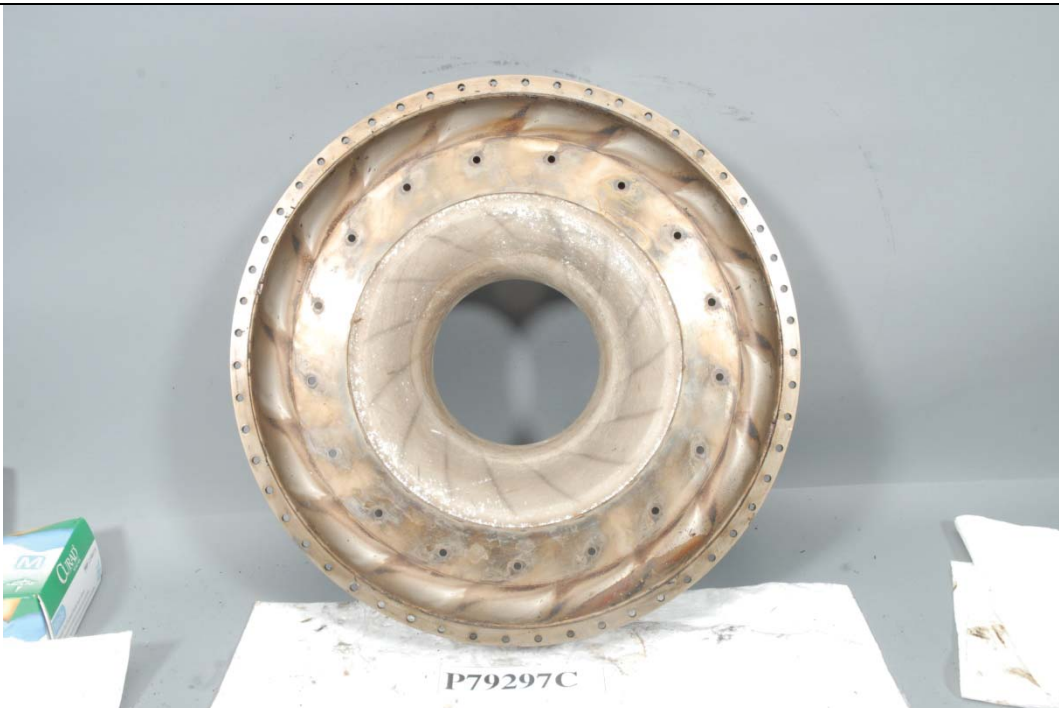
**Figure 105.** P-79297C, First-stage Compressor Diffuser, Debris Compacted in Flow Path

- The first-stage compressor diffuser contained earthen debris and wooden material compacted between the diffuser vanes. (Figure 105)
- (f) Second-Stage Compressor Housing: (Figure 106 and Figure 107)

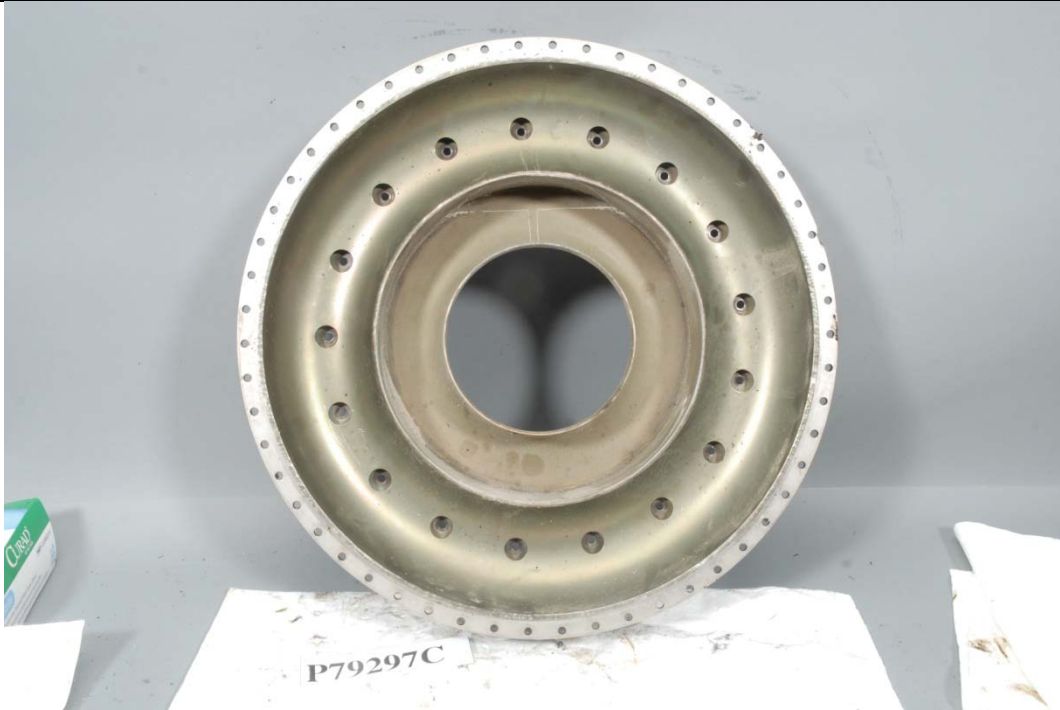
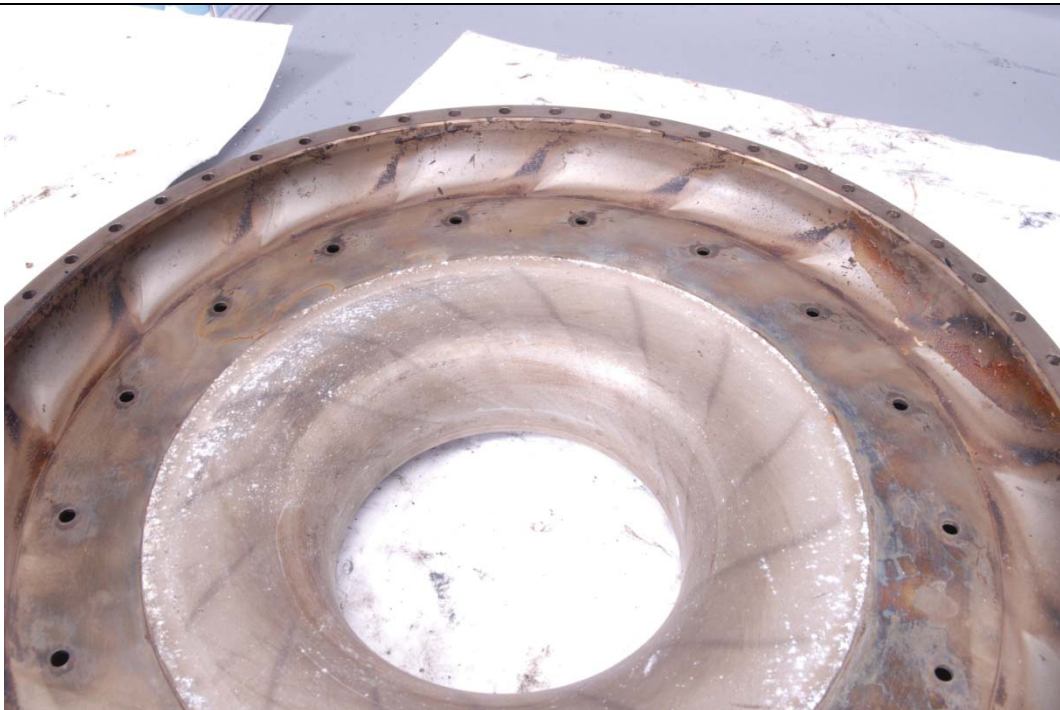
**Figure 106.** P-79297C, Second-Stage Compressor Housing, ALF

- The second-stage compressor housing was intact.
  - The second-stage compressor housing was covered with earthen debris on the external surfaces.
  - The second-stage compressor housing contained debris adhering to the flow path surfaces of the transition area. (Figure 108)

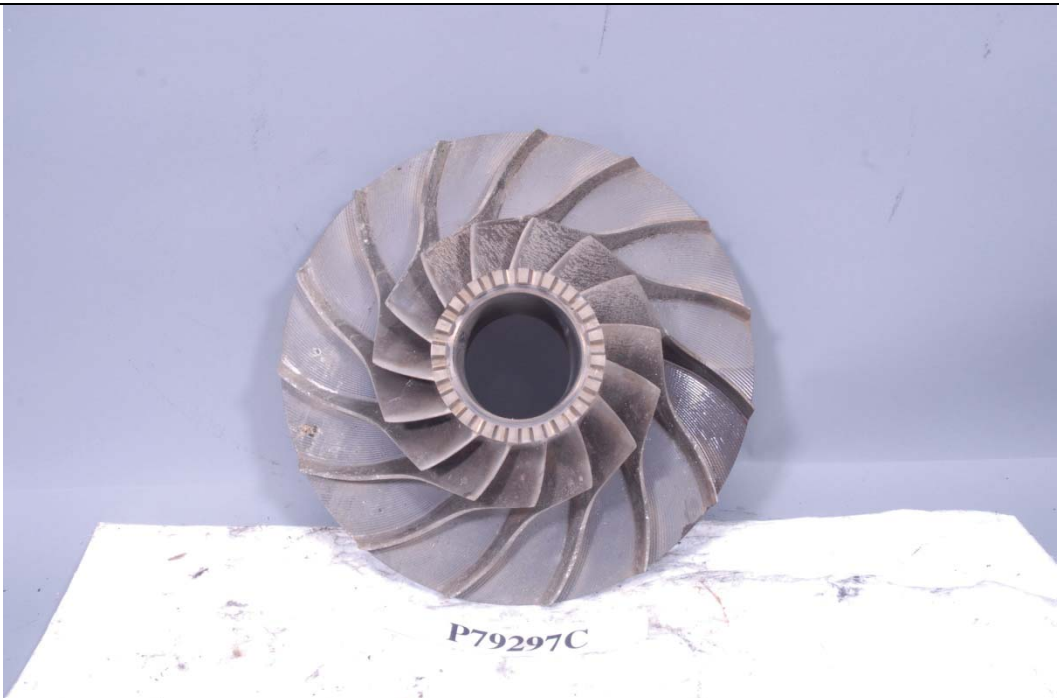
**Figure 109.** P-79297C, Second-Stage Compressor Housing Rotational Scoring

- The second-stage compressor housing displayed rotational scoring in the inducer area corresponding to scoring on the second stage impeller blade shroud line surfaces. (Figure 109)

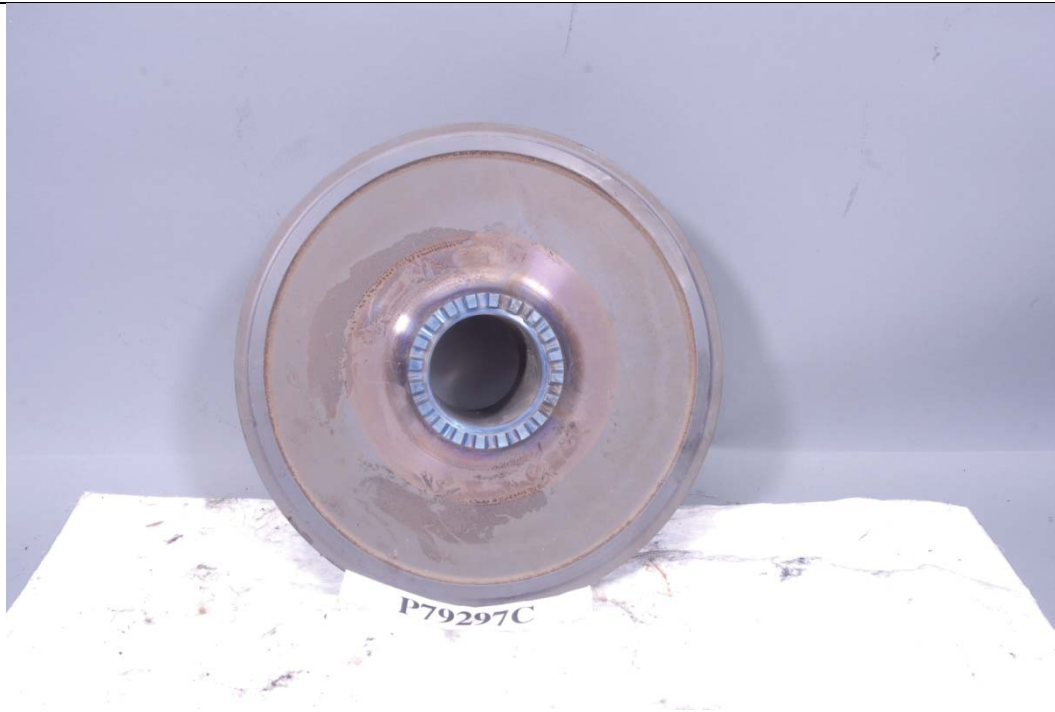
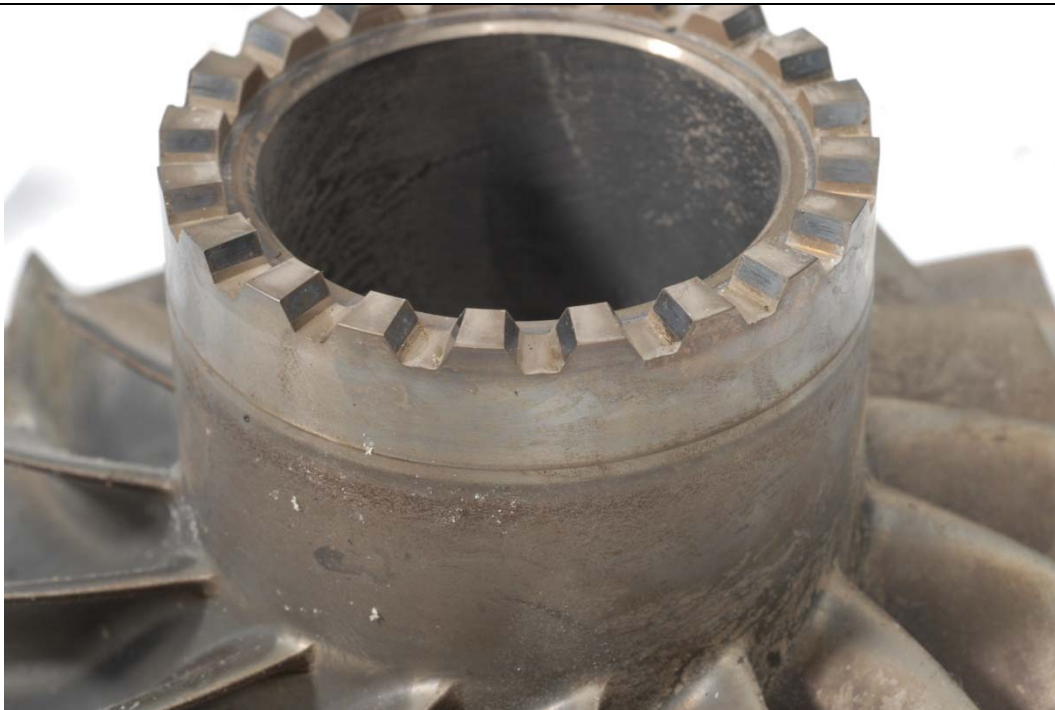
**Figure 110.** P-79297C, Second-Stage Compressor Impeller, FLA

- (g) Second-Stage Compressor Impeller: (Figure 110 and Figure 111)
- Part Number: 893482-5
  - Serial Number: 0-03501-3781
  - Lot Number: 1814
  - The second-stage compressor impeller forward curvic coupling teeth appeared to be undamaged. (Figure 112)

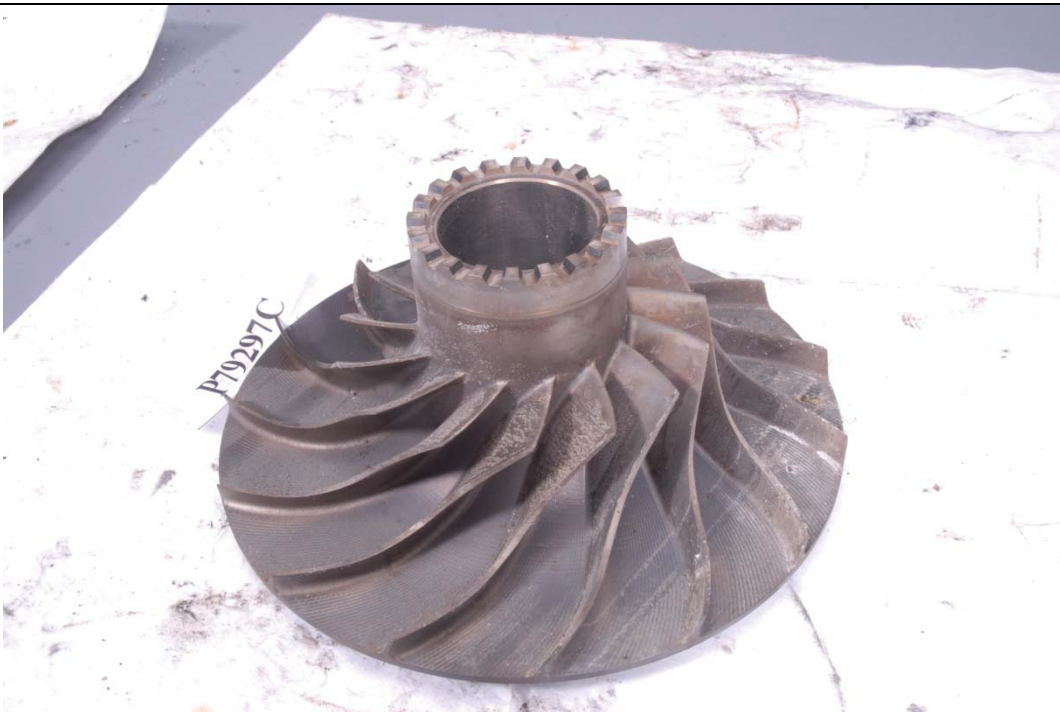
**Figure 113.** P-79297C, Second-Stage Compressor Impeller AFT Curvic

- The second-stage compressor impeller aft curvic coupling teeth appeared to be undamaged. (Figure 113)
  - The second-stage compressor impeller displayed earthen debris adhering to the blades and flow path surfaces. (Figure 114)
  - The second-stage compressor impeller blades displayed rotational scoring on the shroud line edge (Figure 115) with corresponding rotational scoring on the second-stage compressor impeller shroud.
- (h) Second-Stage Compressor Diffuser Vane Assembly: (Figure 116 and Figure 117)
- The second-stage compressor diffuser vane assembly was intact.
  - The second-stage compressor diffuser vane assembly appeared to be undamaged.
  - The second-stage compressor diffuser vane assembly contained what appeared to be building insulation debris between the diffuser vanes. (Figure 118)
